## MONTANA DIVISION

### "NATIONWIDE" PROGRAMMATIC SECTION 4(f) EVALUATION FOR HISTORIC BRIDGES

<b>PROJECT #:</b> BR 9032(65); CN 6296000	<b>DATE:</b> August 30, 2019
<b>PROJECT NAME:</b> Bitterroot River – W of Missoula (South Avenue Bridge Project)	<b>LOCATION:</b> Maclay Bridge, Missoula County; Latitude 46°51'11", Longitude 114°05'52"

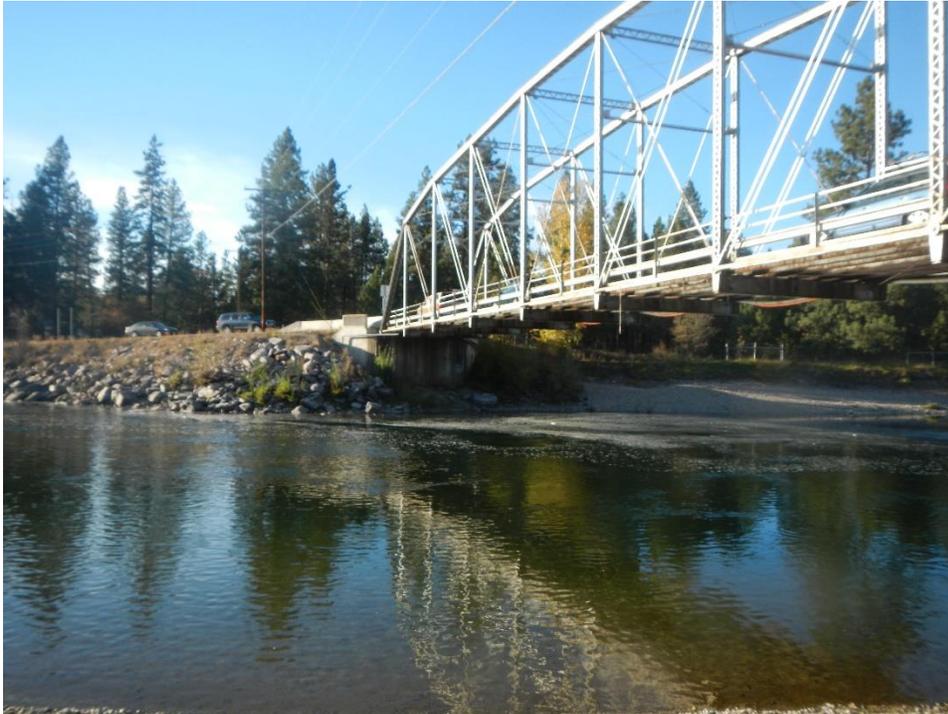
Photo 1: Maclay Bridge and the west approach and abutment area, view from the Bitterroot River

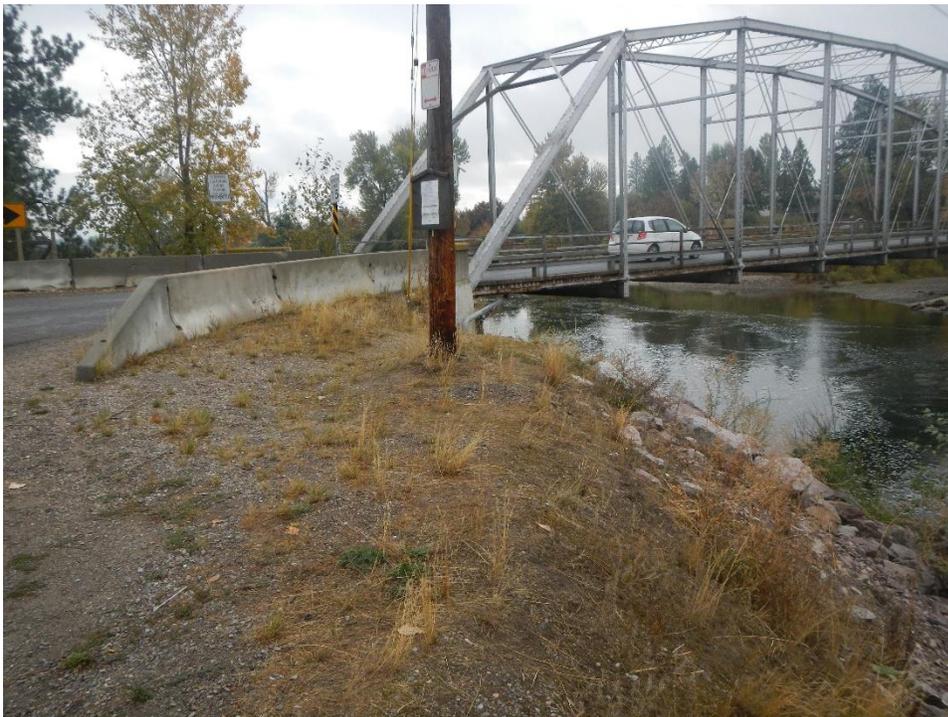
Photo 2: Maclay Bridge and the west approach and abutment area, view from the shoulder of River Pines Road

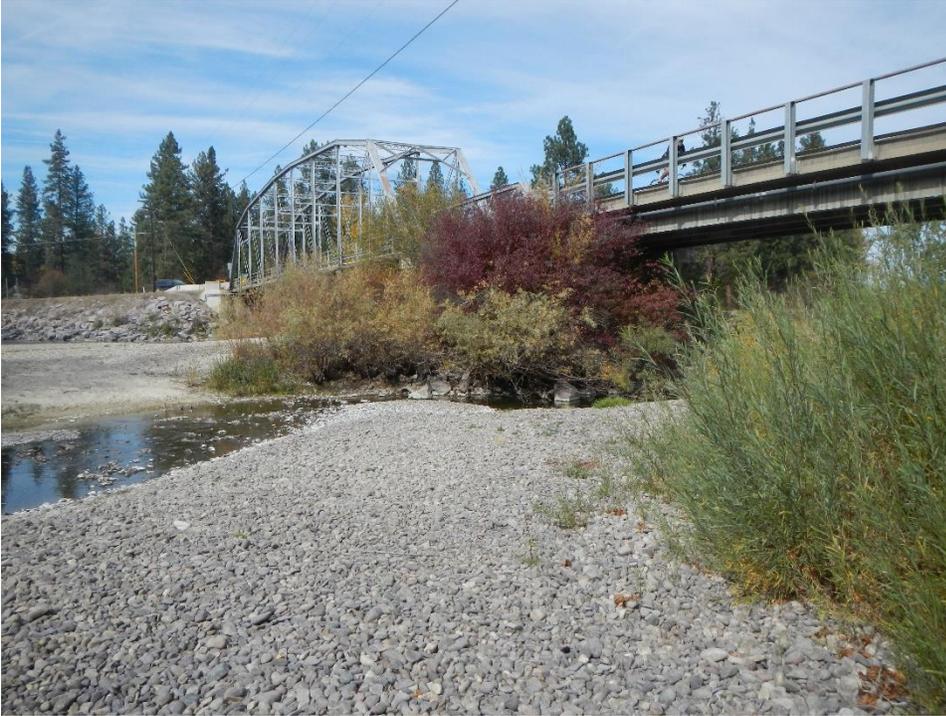
Photo 3: Maclay Bridge and east concrete approach span

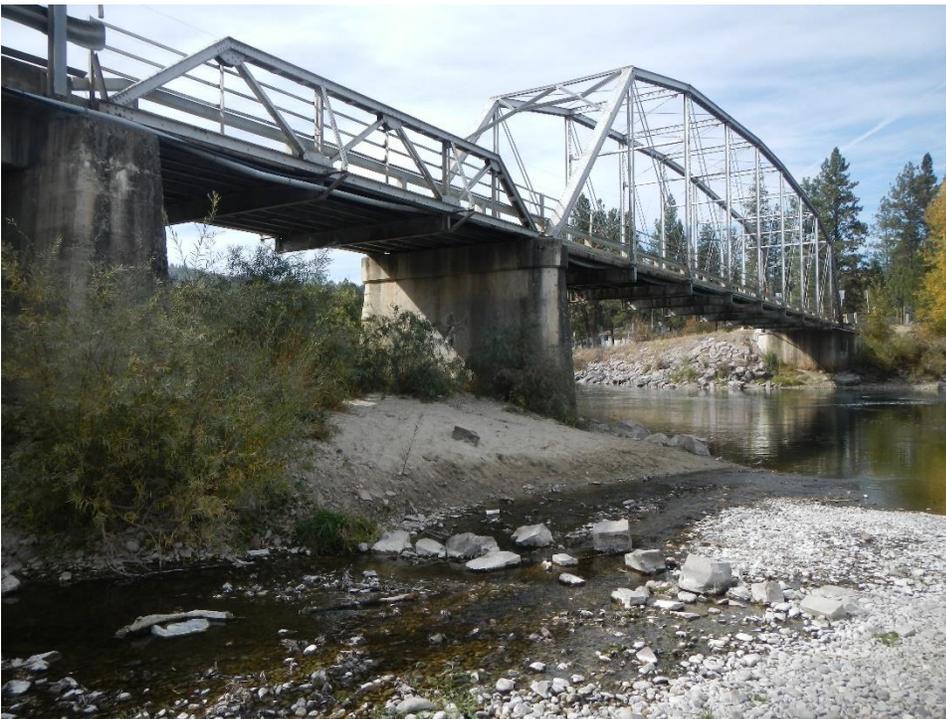
Photo 4: Maclay Bridge and the pony truss segment

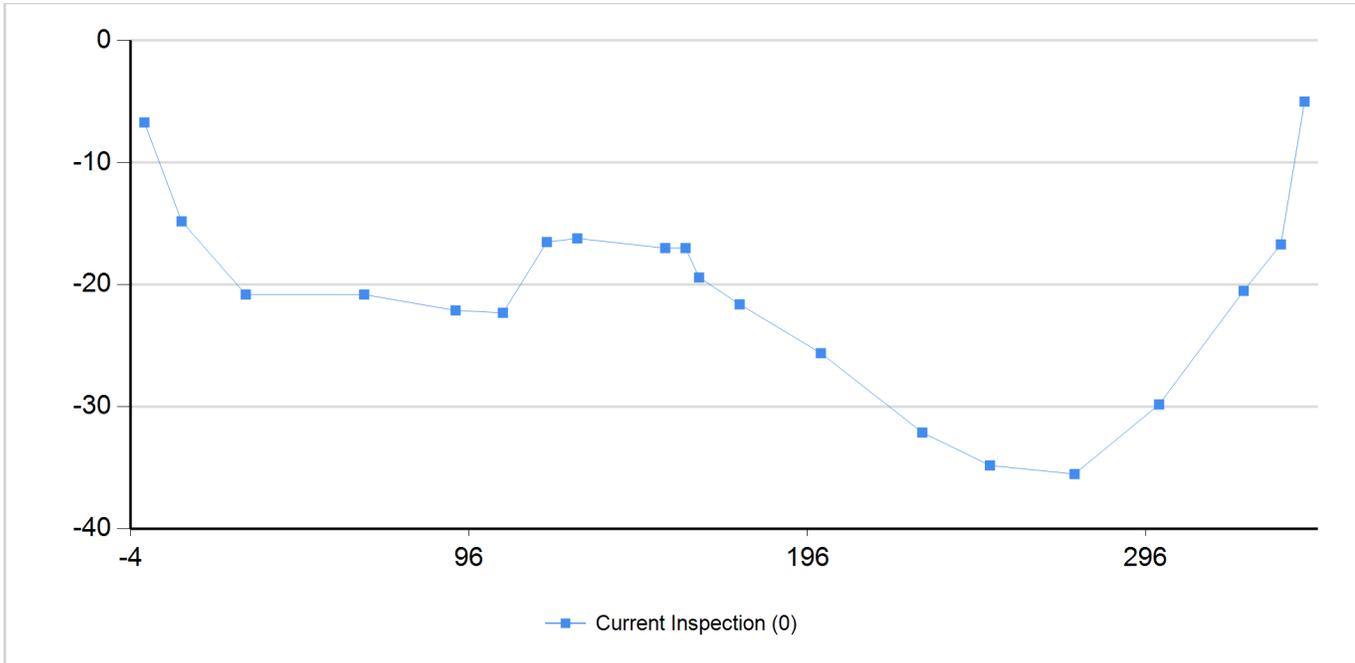
**Underwater Measurements Points Table**

Measure #	Line Depth	Line Distance
1	0	-6.7000000000000002
2	11	-14.8000000000000010
3	30	-20.8000000000000010
4	65	-20.8000000000000010
5	92	-22.1000000000000010
6	106	-22.3000000000000010
7	119	-16.50
8	128	-16.1999999999999990
9	154	-17
10	160	-17
11	164	-19.3999999999999990
12	176	-21.6000000000000010
13	200	-25.6000000000000010
14	230	-32.1000000000000010
15	250	-34.7999999999999970
16	275	-35.50
17	300	-29.8000000000000010
18	325	-20.50
19	336	-16.6999999999999990
20	343	-5
